## HISTORICAL OVERVIEW

## Restored Tiles in the Heart of Central Park

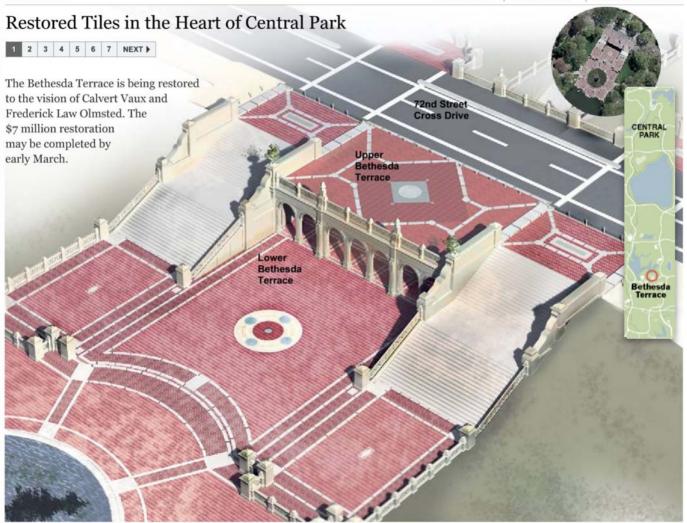
The split-level terrace overlooking the park's lake, is composed of 16,000 tiles. Over the decades, the 50-ton ceiling had weakened and its tiles had deteriorated. The tiles have been in storage since being removed in the 1980s during an initial repair effort. The Central Park Conservancy renewed its plan after getting a \$3.5 million gift from the estate of Evelyn West in 2002.
